Manhole Inspection Summary

Manhole # S37U__018MH

Location Address: **R. 1611 Light St**

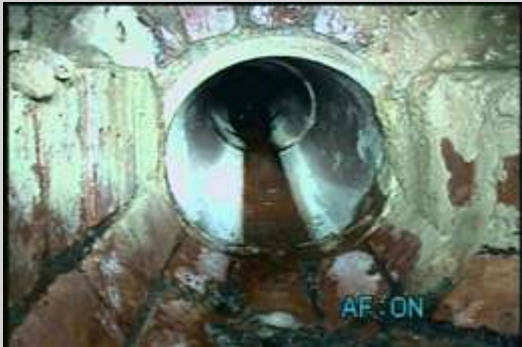
12 O'Clock Outflow

8 in. Circular Gravity Sewer
Pipe Out @ 12 O'Clock

Pipe Material: Clay ☐ Pipe Lined

Invert Depth: 9.25 (ft.) Flow Characteristics: Fast

Deposits: ☒ None ☐ Mud ☐ Sludge ☐ Debris ☐ Grease

Infiltration: None

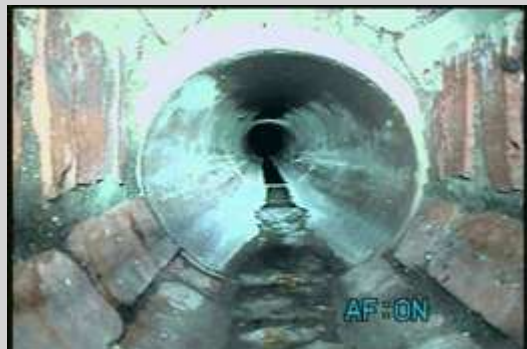
6 O'Clock Inflow

8 in. Circular Gravity Sewer
Pipe In @ 6 O'Clock

Pipe Material: **Clay** ☐ Pipe Lined

Infiltration: **None**
